REPAIR OF UTILITY CUTS WITHIN INTERLOCKING CONCRETE PAVEMENTS

Revised August 2023

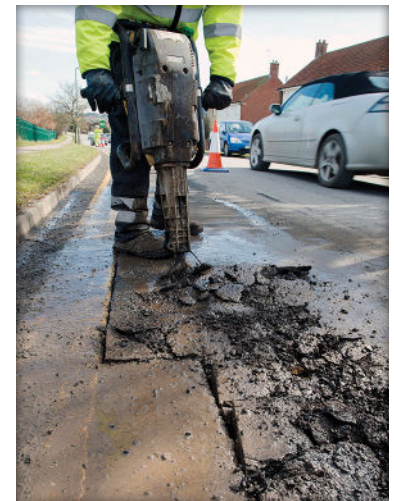
Figure 1. Repairs to utilities are a common sight in cities, incurring costs to cities and taxpayers.

North American cities have thousands of utility cuts made in their streets each year. Figure 1 shows a daily occurrence in most cities: repairs to underground utility lines for water, sewer, gas, electric, steam, phone, fiber-optic, or cable services. A sample is given below of the number of annual utility cuts in a few cities.

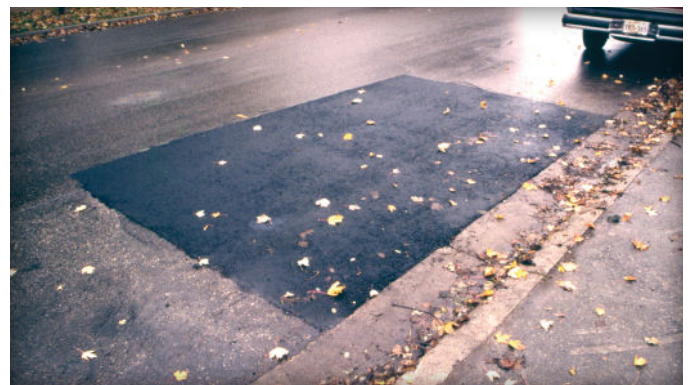
Figure 7. Pavement damage from settlement and shrinkage of cold patch asphalt.

Any break in monolithic pavement, e.g., joints, cuts or cracks, normally shortens pavement life because the continuity of the material is broken as shown in Figure 7. In contrast, the joints of the modular units in interlocking concrete pavements maintain structural continuity.

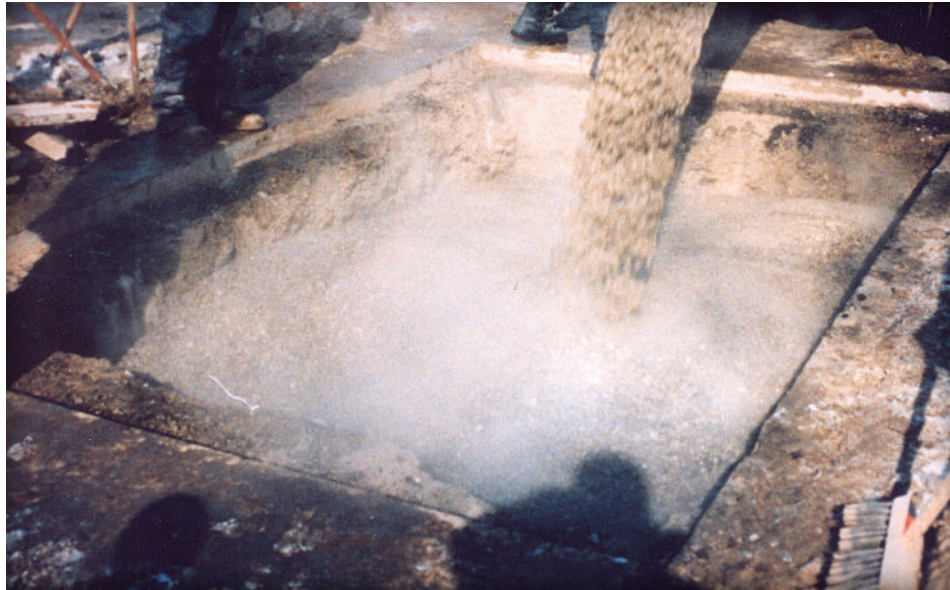
Figure 8. Low density concrete fill (unshrinkable fill) poured into a utility trench from a ready-mix concrete truck.

Unshrinkable fill being poured into a trench is shown in Figure 8. The fill flows into undercuts providing additional support, and in places where the soil or base has fallen from the sides of the trench. These places are normally impossible to completely fill and compact with aggregate base or backfill material.
