# Tech Spec 7

## Repair of Utility Cuts Using Interlocking Concrete Pavers

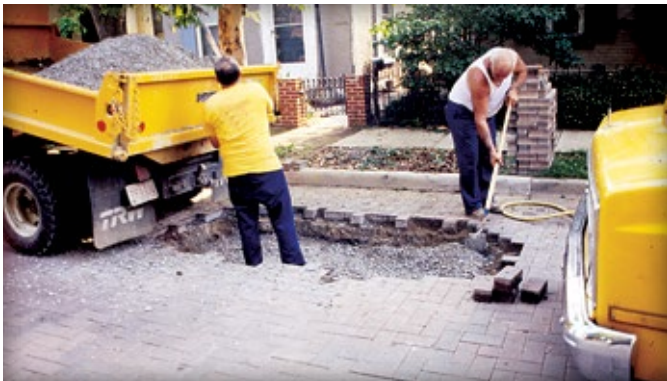
Figure 2. Removal of concrete pavers for a gas line repair in Dayton, Ohio.

Figures 2, 3, 4, 5 and 6 show the process of repair and illustrate the continuity of the paver surface after it is completed. The reinstated units are knitted into existing ones through the interlocking paving pattern and sand filled joints. Besides providing a pavement surface without cuts, the joints distribute loads by

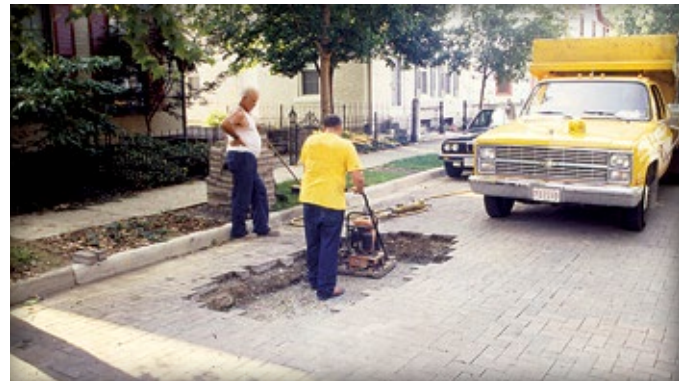
Figure 3. Compaction of the base

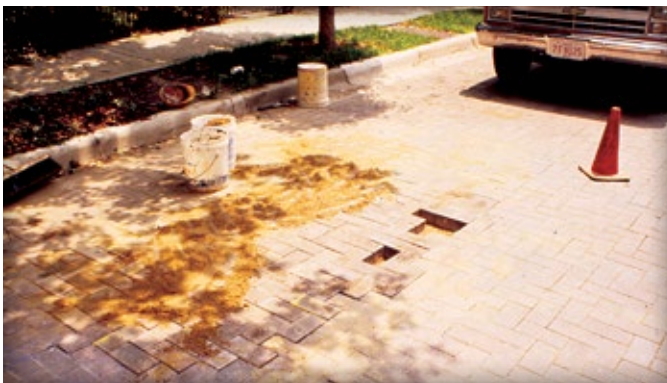
Figure 4. Reinstatement of the pavers, bedding and joint sand

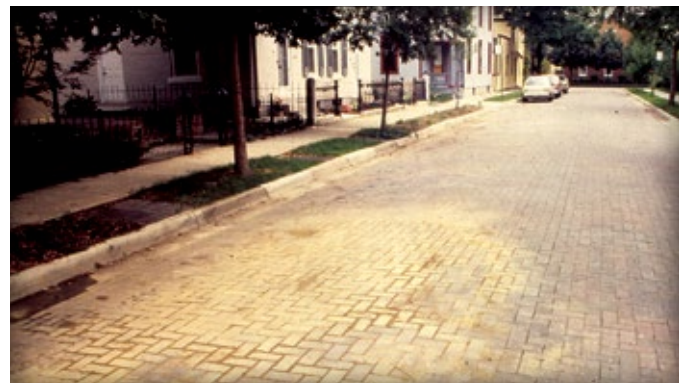
Figure 5. The final paver surface is continuous. There are no cuts or damage to the pavement.

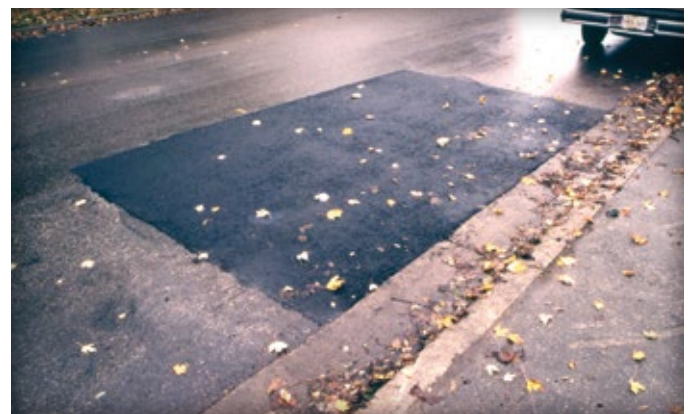
Figure 7. Pavement damage from settlement and shrinkage of cold patch asphalt.

Figure 7 shows the result of settlement and shrinkage of the cold patch asphalt in a London, Ontario, utility cut. The change in dimensions causes the edge of the cut asphalt to deteriorate, and settlement decreases riding quality.

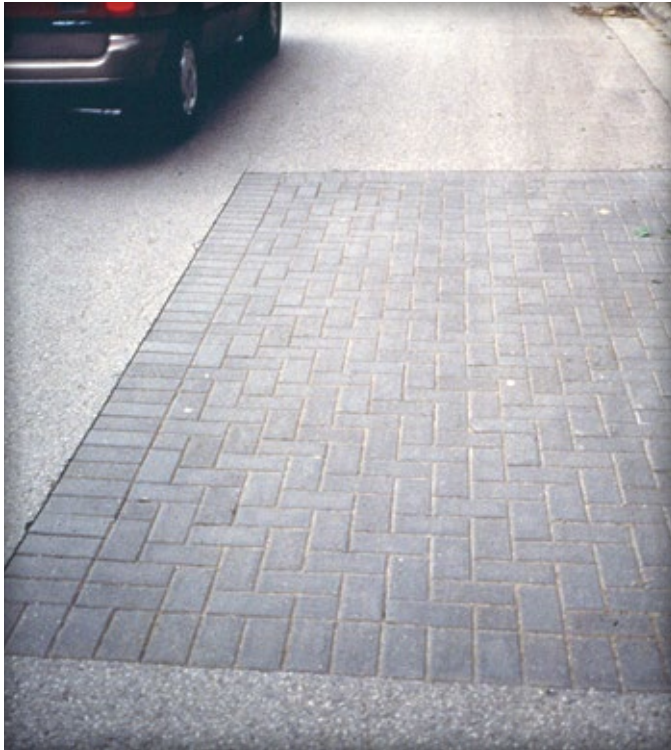
Figure 8. Utility cut repair in a residential area in London, Ontario.

Concrete pavers on low density concrete fill have been successfully used as a replacement for cold patch asphalt (Figures 8 and 9). They were first used as a temporary repair with the intent of being removed in the spring. However, the pavers performed so well that the City of London left them in place indefinitely. Several repairs were in streets subject to heavy truck traffic, as well as residential streets. Costs were less than using cold patch asphalt.

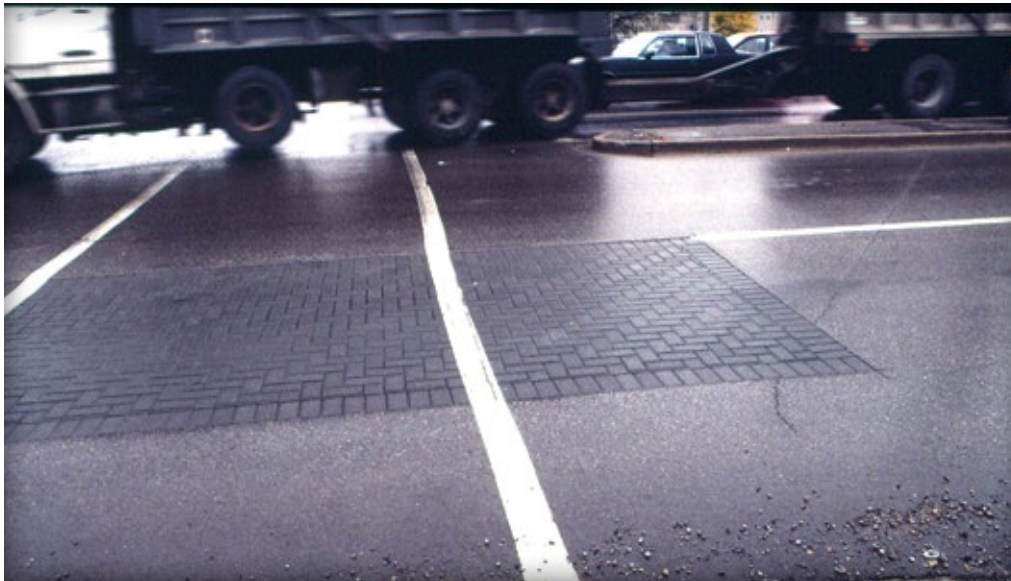
Figure 10. A patch of pavers in a heavily trafficked intersection in London, Ontario

to match the appearance of the asphalt so there would be no substantial differences in appearance. Figure 10 shows such a patch of pavers blending with the surrounding pavement.

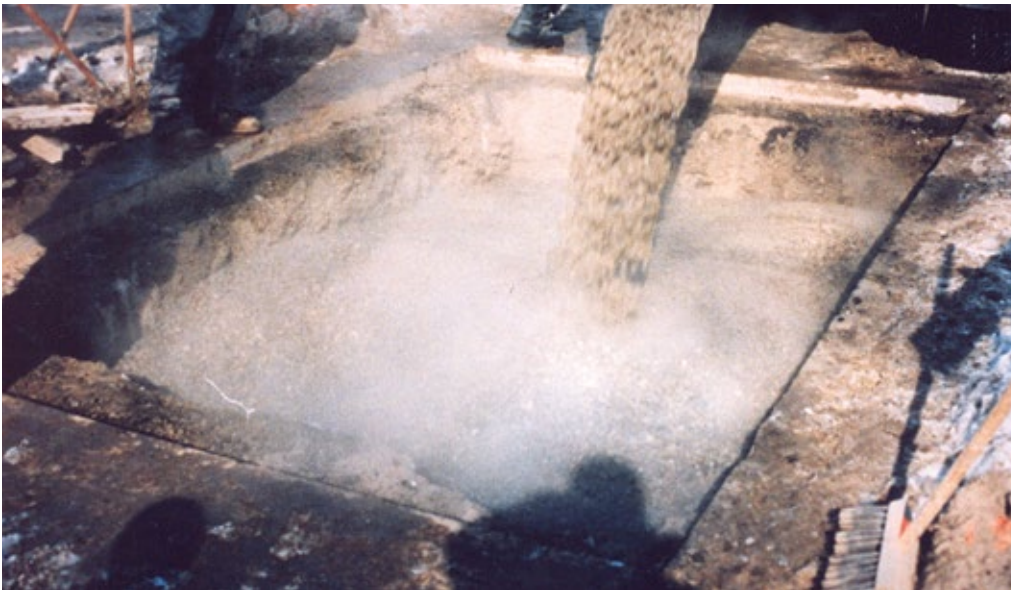
Figure 11. Low density concrete fill (unshrinkable fill) poured into a utility trench from a ready-mix concrete truck.

**Unshrinkable fill** poured into the trench is shown in Figure 11. The fill flows into undercuts, under the edge of the cut asphalt (providing additional support), and in places where the soil or base has fallen from the sides of the trench. These places are normally impossible to fill and compact with aggregate base or backfill material.

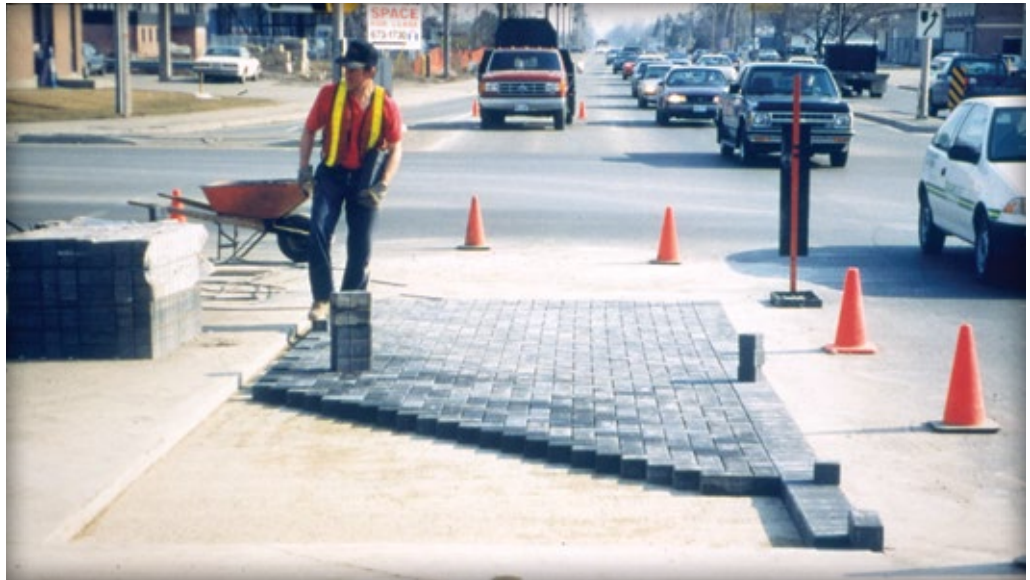
Figure 12. Pavers are laid in a 90 degree herringbone pattern between the border courses.

ers [nominally 4 in. by 8 in. (100 mm x 200 mm)] should be placed against the cut asphalt sides as a border course. They should be placed in a sailor course, i.e., the long side against the asphalt. No cut paver should be smaller than one third of a unit. Place pavers between the border course in a 90 degree herringbone pattern (Figure 12). Joints between pavers should be between  $\frac{1}{16}$  and  $\frac{5}{16}$  in. (2 to 5 mm). Compact the pavers with a minimum 5,000 lbf (22 kN) plate compactor. Make at least four passes with the plate compactor. A small test area of pavers may need to be compacted to check the amount of settlement. The bedding sand thickness should

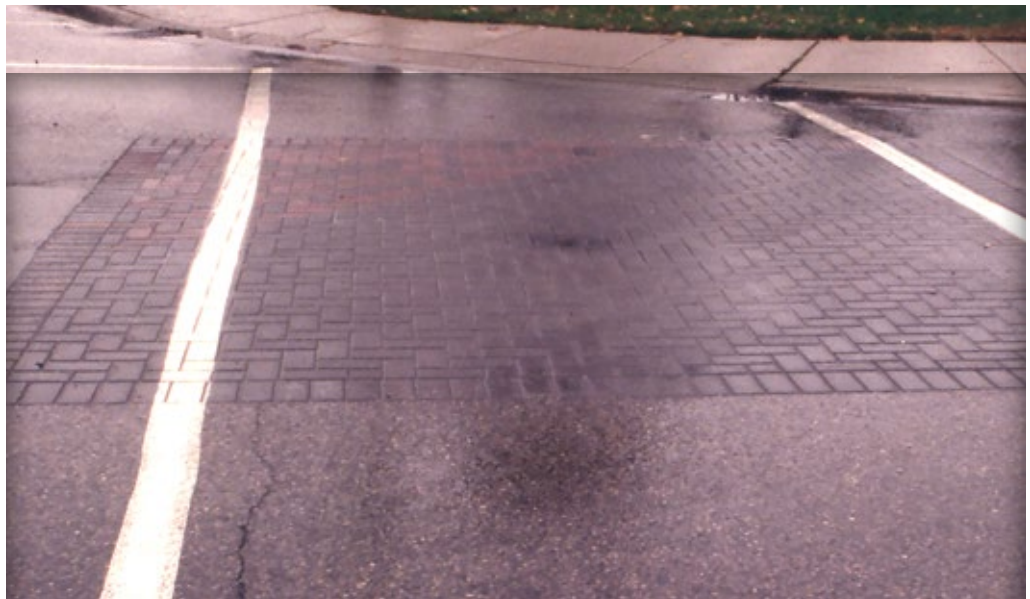
Figure 13. Concrete pavers in utility cuts can be painted as any other pavement.

Spread, sweep and compact sand into the joints. The joint sand is typically finer than the bedding sand, and should conform to the grading requirements of ASTM C 144 (11) or CSA A179 (10). The joints must be completely full of sand after compaction. Remove excess sand and other debris. The pavers may be painted with the same lane, traffic, or crosswalk markings as any other concrete pavements (Figure 13).
